Manhole Inspection Summary

Manhole # S21AA_009MH

Insp Date: **9/11/07 9:49 AM**

Location Address: **1723 LAFAYETTE AVE**

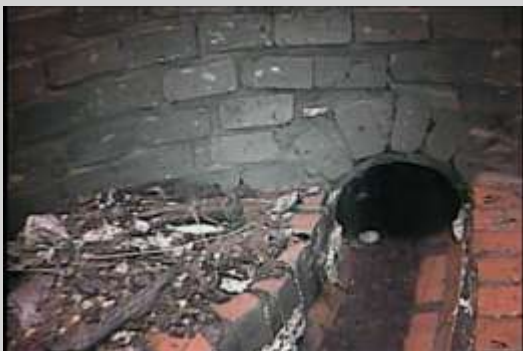
3 O'Clock Inflow

Pipe Height: **8.4** (in.) Rod and Bar (Angled)

Pipe Material: **Clay** ☐ Pipe Lined

Infiltration: **None** Pipe Seal Cond: **Sound**
